South Texas Project
Unit 2
Docket No. STN 50-499
Licensee Event Report 01-002
Manual Reactor Trip

FACILITY NAME (1) South Texas Unit 2						DOCKET NUMBER (2) 05000 499			PAGE (3) 1 OF 4		
TITLE (4) Manual Reactor Trip as a Result of Switchyard Breaker Failure											
EVENT DATE (5)			LER NUMBER (6)			REPORT DATE (7)			OTHER FACILITIES INVOLVED (8)		
MO	DAY	YEAR	YEAR	SEQUENTIAL NUMBER	REV NO	MO	DAY	YEAR	FACILITY NAME	DOCKET NUMBER	
03	01	2001	01	002	00	04	23	2001	FACILITY NAME	DOCKET NUMBER	
									05000		
									05000		
OPERATING MODE (9)		THIS REPORT IS SUBMITTED PURSUANT TO THE REQUIREMENTS OF 10 CFR §: (Check all that apply) (11)									
1		20.2201(b)		20.2203(a)(3)(ii)		50.73(a)(2)(ii)(B)		50.73(a)(2)(ix)(A)			
POWER LEVEL (10)		95%		20.2201(d)		20.2203(a)(4)		50.73(a)(2)(iii)		50.73(a)(2)(x)

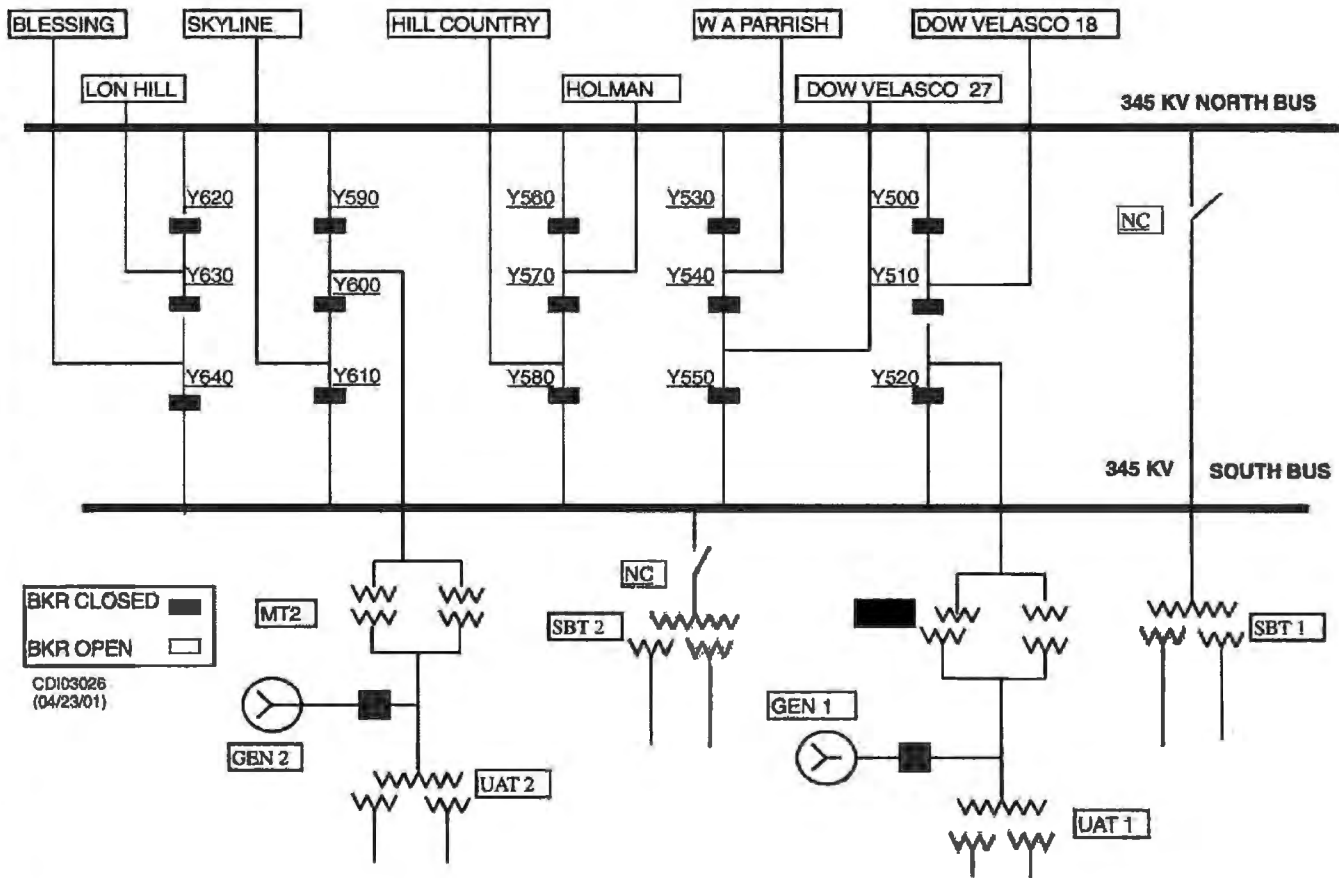
345 kV Switchyard Normal Operation

On March 1, 2001, preparations were underway to align the main 345kV switchyard breakers for North Bus maintenance. At approximately 0700 CST switchyard breakers Y600 and Y610 were opened. The manual disconnect for the "Skyline" offsite transmission feed was then opened to take the "Skyline" circuit out of service while the North Bus was out of service. After the "Skyline" manual disconnect was opened, breakers Y600 and Y610 were closed. Unknown to the operating and switchyard crews, the C phase pole of breaker Y600 remained opened (indicated fully closed). At 0821 switchyard breaker Y590 was opened. With the C phase pole of breaker Y600 still opened, the Control Room received electrical panel alarms and Circulating Water Pump 21 tripped offline on a phase balance current relay (46 relay). The open C phase pole created a phase imbalance condition that was sensed by generator and Circulating Water motor protection relays once breaker Y590 was opened. Standby Bus 2F and Auxiliary Bus 2H high voltage alarms and a generator negative phase sequence current alarm were received. This was followed closely by the trip of the remaining operating Circulating Water Pumps 22 and 24, requiring the operating crew to initiate a manual reactor trip in accordance with plant procedures. All control rods fully inserted. The Auxiliary Feedwater System actuated on low-low steam generator water level as expected. All safety equipment operated as required. The control room crew closed the main steam isolation valves due to the condenser not being available.
